Metallized Polypropylene Film Energy Storage Capacitors For Low Pulse Duty

Abstract

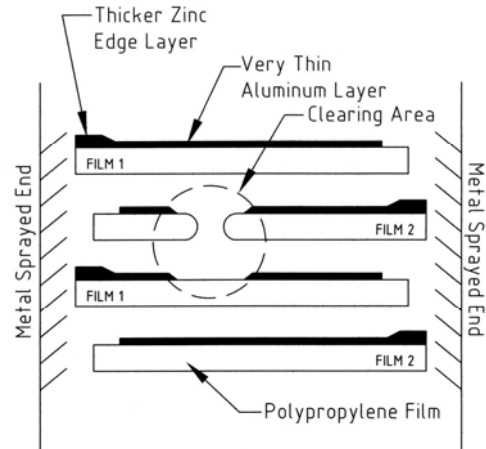
Figure 2. Metallized film layers depicting a self-healing event.

Each film in the capacitor element has a thin metallization applied to the surface, usually aluminum or zinc with a thickness typically less than 100 nm thick. [1] The metallization allows phenomena called self-healing where a localized breakdown in the film during operation due to pinholes, flaws or impurities is removed from the capacitor. A schematic picture of the self-healing process is shown in Figure 2 that also depicts the reinforced edge that will be discussed. What happens when the self-healing occurs can lead to additional flaws in the dielectric with further breakdown or to normal continued operation that will also be further discussed.

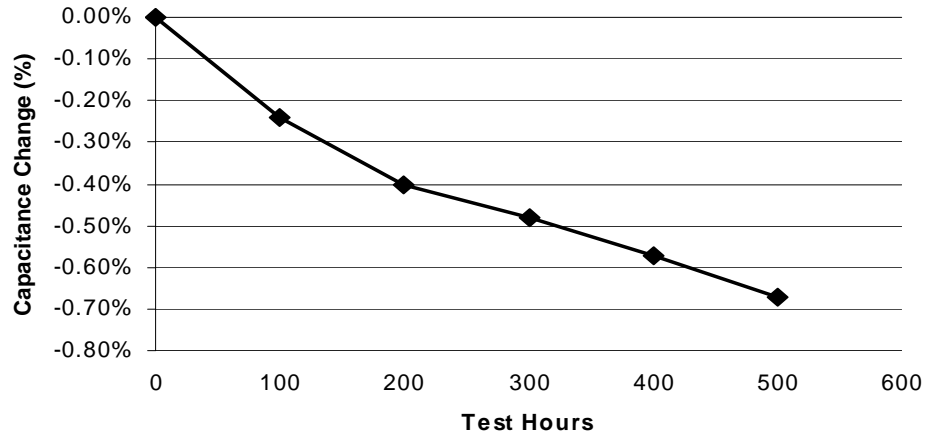
Figure 4. Capacitance change during 10 day humidity test with periodic pulsing

No failures occurred in either of the two humidity tests. The capacitors in the 65°C humidity test exhibited almost no capacitance change over the 10-day test period. The capacitors that were tested under 50°C humidity with periodic pulsing of one every 5 minutes exhibited a capacitance loss of less than 0.75%. The 21-day test period is equivalent to 508 hours and figure 4 shows the capacitance change measured every 100 hours during this testing. The capacitors were opened and analyzed after this testing was completed to determine the source of this small capacitance loss. There was no metal erosion typical of moisture penetration observed and self-healing or clearing sites were found mostly toward the outside of the capacitor elements and concentrated on the lower tension flat surfaces. The observation of a higher concentration of clearings on the wound element outside and the lower tension surfaces is an expected one and has been reported in other sources [1,4].

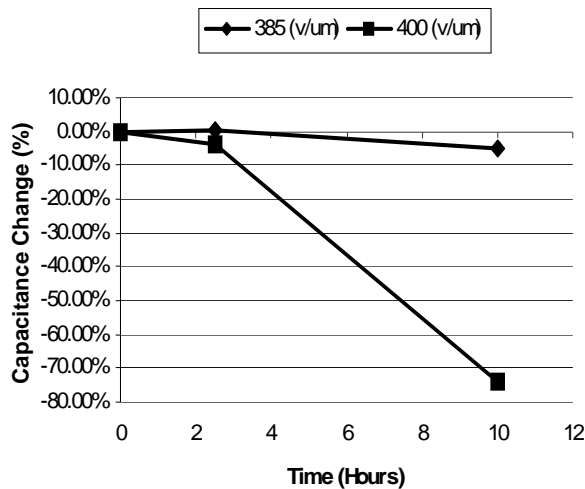
Figure 5. Capacitance change for continuous dc voltage at 50°C

The results of the voltage hold testing for 10 hours at 50°C are depicted in Figure 5. It can be observed that after 2.5 hours capacitance loss was a few percent at 400 volts/μm and over 70% at 10 hours. At the 385 volts/μm condition the capacitance loss was only a few percent after 10 hours. This type of testing shows that a total amount of hold time versus temperature and voltage can be determined experimentally.

Test groups E and F are examples of steady state DC aging at two different voltages at the same accelerated temperature of 50°C. Although a low pulse duty capacitor is not normally designed for this type of duty there is often a significant hold time in some applications between when full charge is achieved and the capacitor is discharged. In this testing it was determined that the capacitance change was very large after 10 hours at 400 volts/micrometer of metallized polypropylene thickness. The test was therefore repeated by reducing the voltage to 385 volts per micrometer of metallized polypropylene thickness.

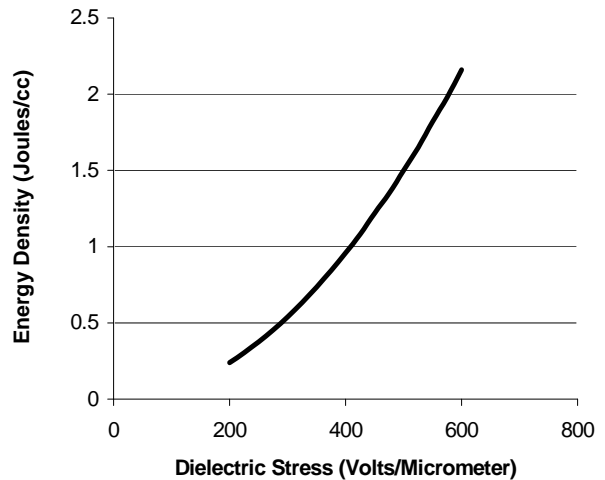
Figure 6. Energy density versus dielectric stress

The final test group G shows a larger capacitor can be manufactured using this low pulse duty metallized polypropylene capacitor technology. Figure 6 depicts finished packaged capacitor energy in Joules per cubic centimeter. The capacitors in cases described in this paper are in the range of 1.2 to 1.5 J/cc. The group G capacitor was approximately 1.5 J/cc and was approximately 1.5 Kilo-joule per Kilo-gram. Achieving this type of design in a plastic case plastic without oil impregnation increases the size and weight density by approximately 10%.

Test group G was an example of a larger energy storage capacitor at a higher stress in order to push the envelope of what had been achieved. This capacitor was using capacitor elements fabricated with a metallized polypropylene dielectric thickness of ten micrometers. In this capacitor design two elements were wired in series and multiple elements in parallel to produce a capacitor of 300 μF with a voltage rating of 10,000 volts peak. The voltage stress on this design was 500 volts per micrometer and the stored capacitor energy was 15 kilojoules. This capacitor was charged to its rated voltage of 10,000 volts dc and discharged after 10 seconds thru a 0.4 ohm load. After 100 cycles, no failures were produced in the six samples with less than a 1% capacitance drop.
